Aegis Chemical Solutions

Technical Newsletter

Volume 09, February 2019

CORROSION FAILURE ANALYSIS

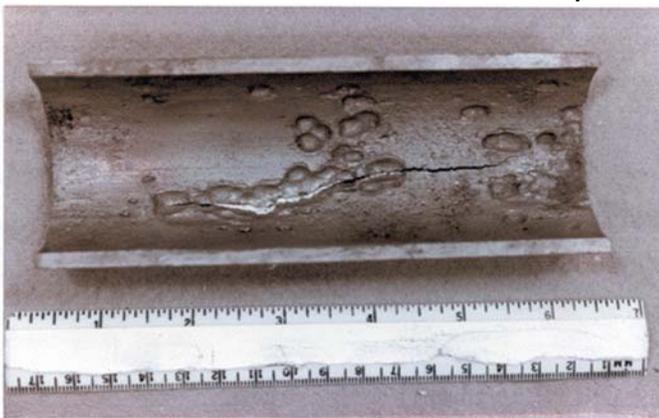
Interconnected Pits or Wormhole Pattern in Pipe

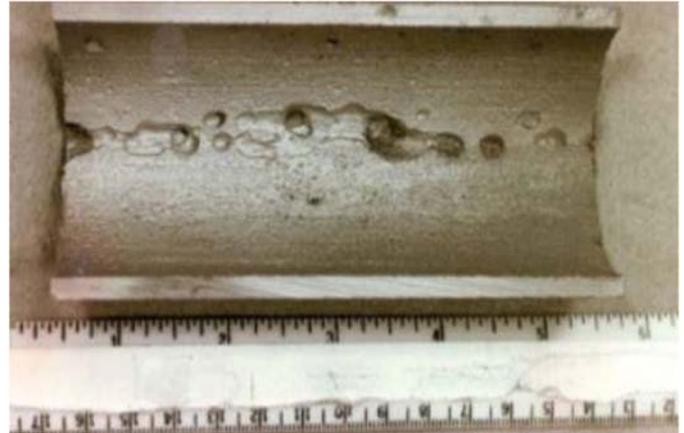
Wormhole in Pipe

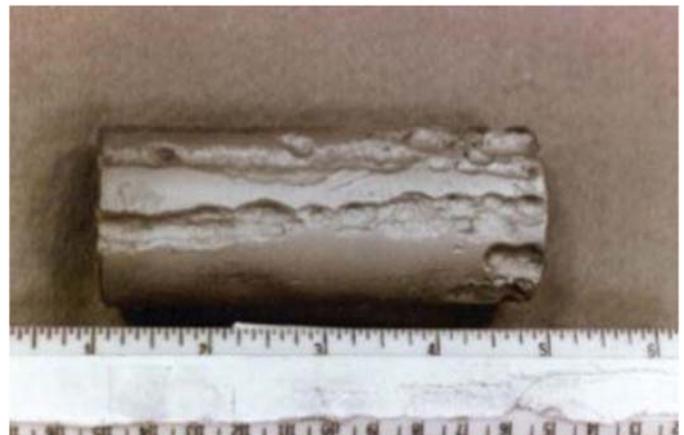
Wormhole on Sucker Rod

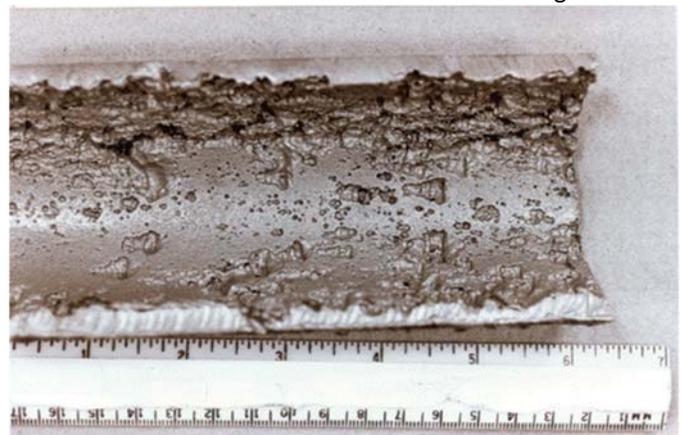
Sharp Edges

Corrosion occurred where water condensed in gas well

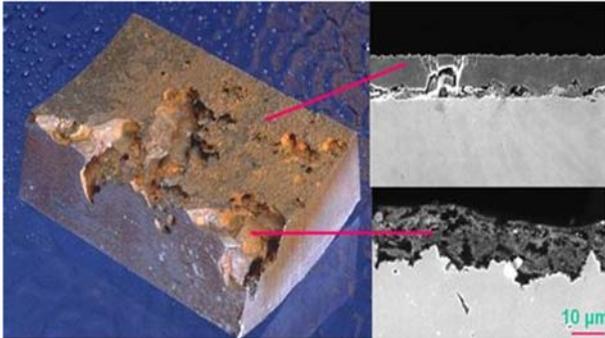
Sharp Edges, Interconnected Pits, and Undercutting

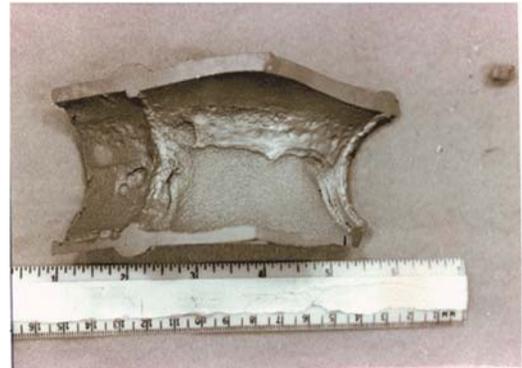
High Velocity
Sharp edges worn away

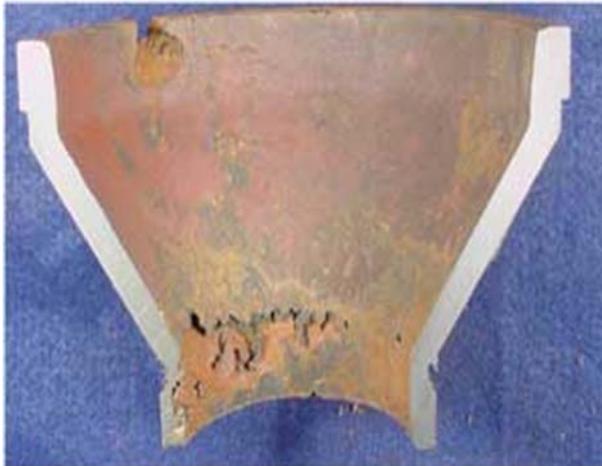
Heat Affected Zone (HAZ) – Sharp edges and Undercutting

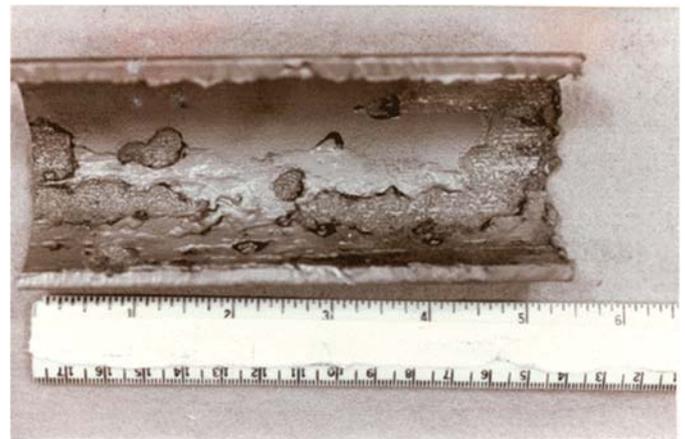
Mesa Corrosion

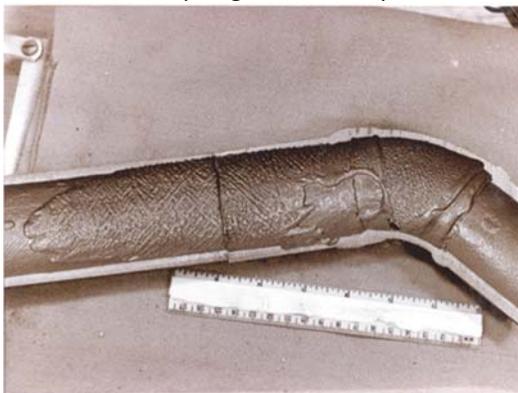
High Velocity
Sharp edges worn away

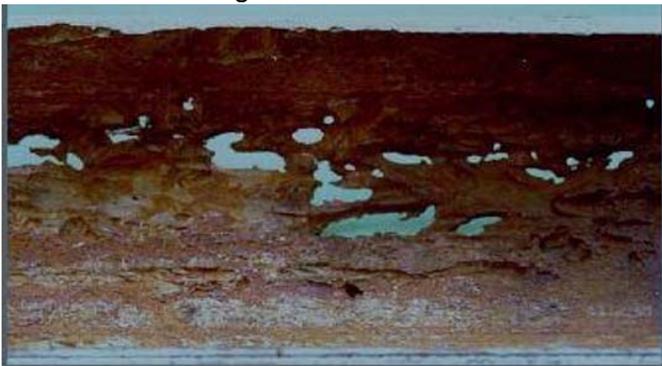
An oil well developed a penetrating localized attack of CO₂ corrosion. The leak occurred after 18 months of service. The well began producing formation water well in advance of the well design predictions. Water cut increased from 5% after two months to 80% after 17 months. The CO₂ molar fraction in the gas phase was 30%, and the bubble point pressure was 5.2 bar. The wellhead pressure was always higher than this, so this was a liquid-only oil well with a CO₂ partial pressure of 1.6 bar. The calculated pH was 5 – 5.5. Both detailed caliper data over the whole well depth and detailed inspection of the recovered well string were available. The tubing had penetrating mesa attack close to the top of the well, at around 100m depth corresponding to 4.6mm/yr. corrosion

rate based on the total production period. A section of the tubing where penetrating localized attack was found is shown in the photograph below. Further down in the well, the corrosion rate was measured at 0.3 – 0.9mm/yr. by caliper data.

Penetrating Localized Attack in Oil Well

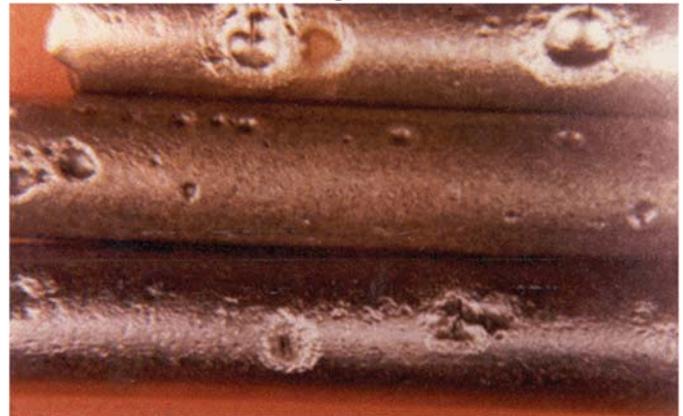
Isolated Pitting on Sucker Rod

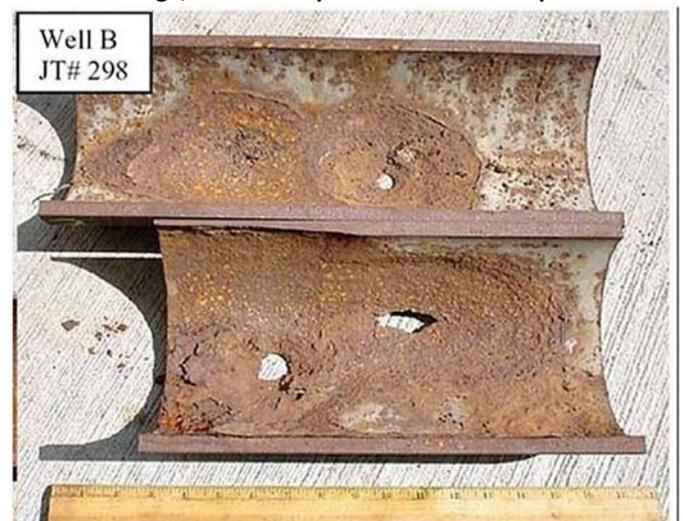
Large, Round Deep Pits on Inside of Pipe

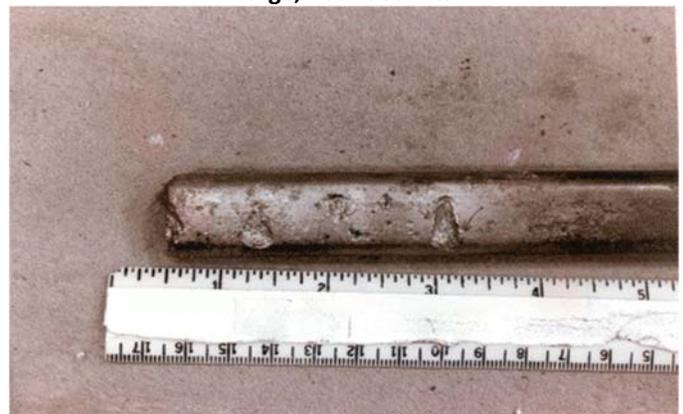
Large, Rounded Pits

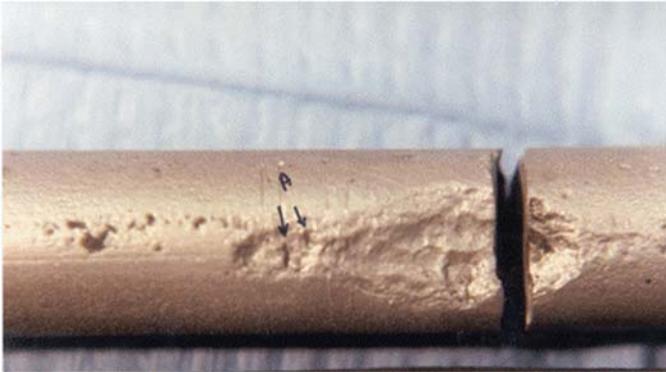
Cracking at Pit

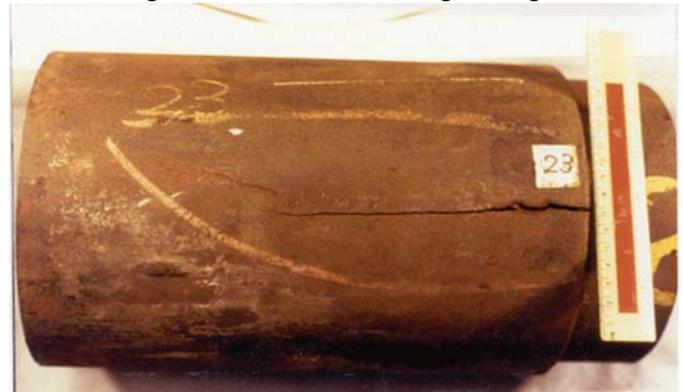
Hydrogen Embrittlement

Cracking due to H₂S corrosion of high strength steel

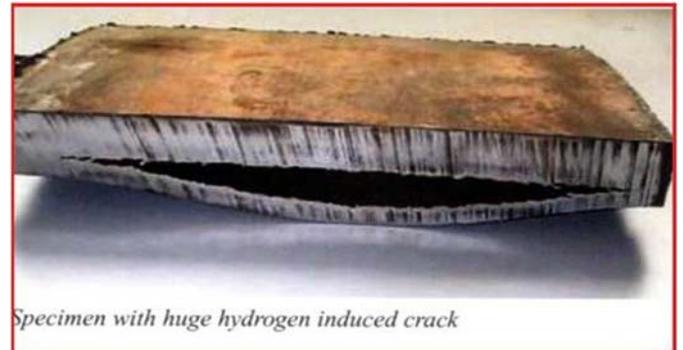
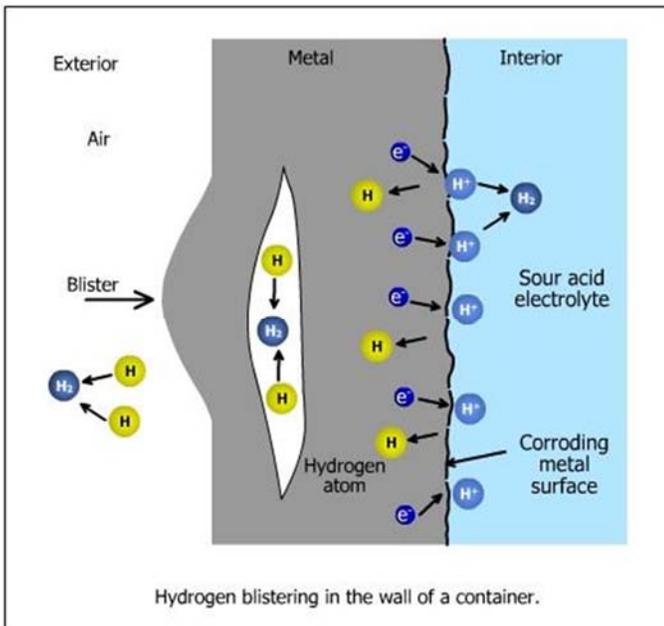
Hydrogen Induced Cracking

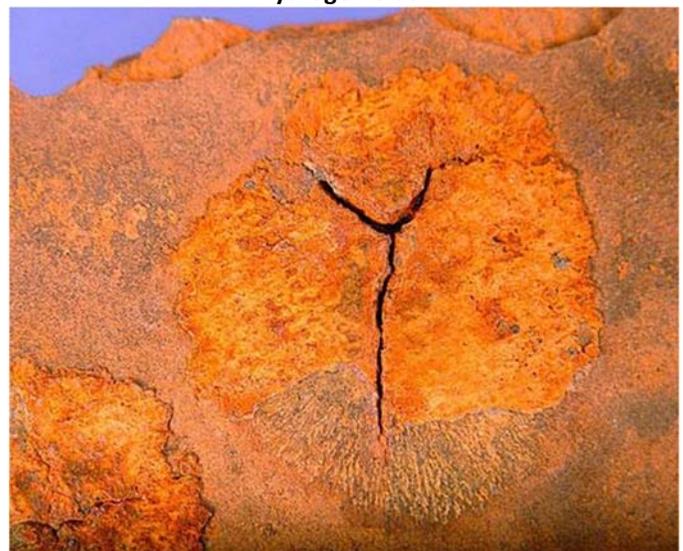
Hydrogen Crack

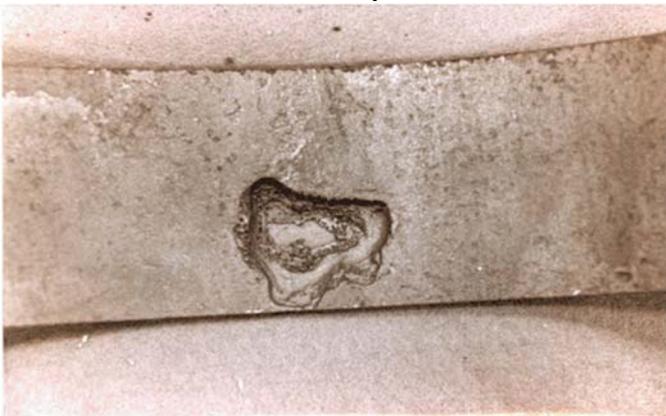
Concentric or Layered Pits

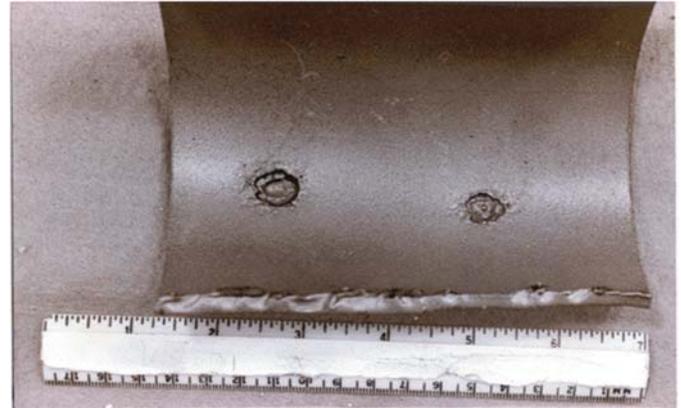
Layered Pits

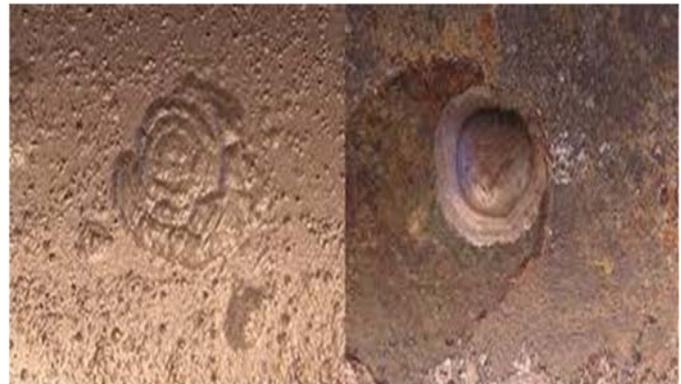
Concentric Pits

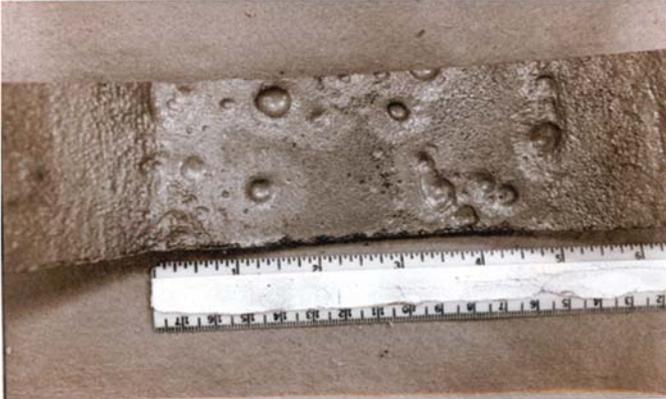
Wide Shallow Pits

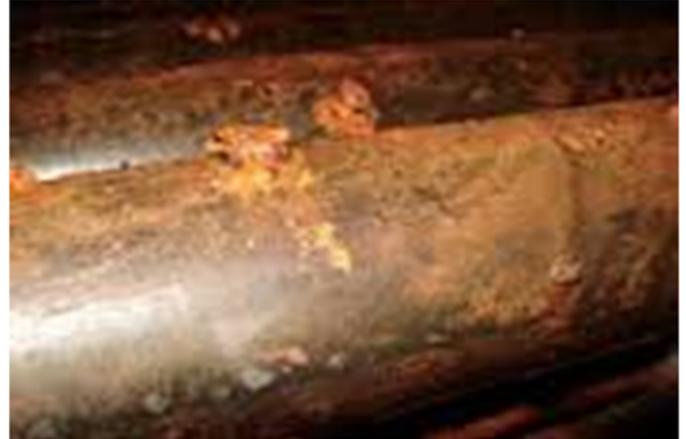
Tubercles

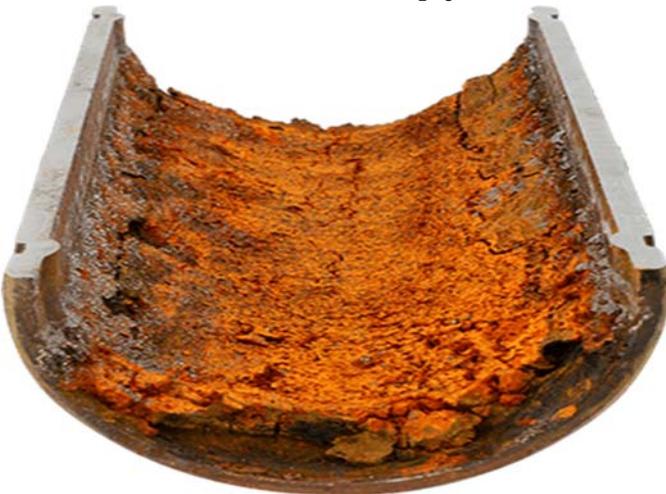
Reddish Yellow Fe_2O_3

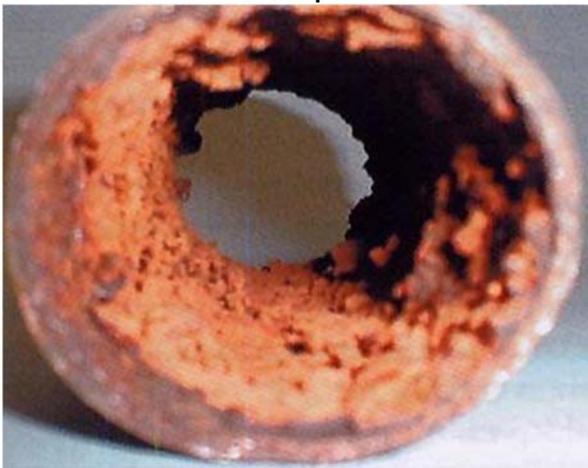
Fe_2O_3 Deposits

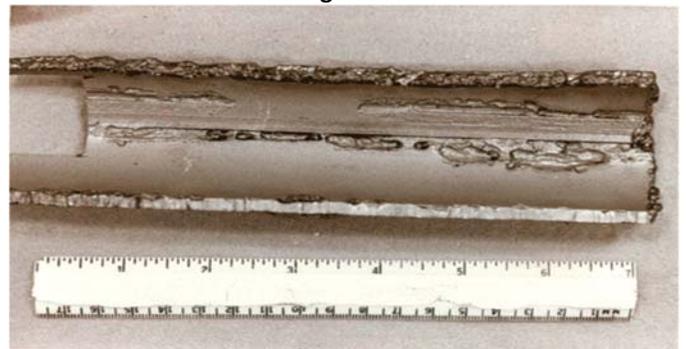
Pitting at Seam

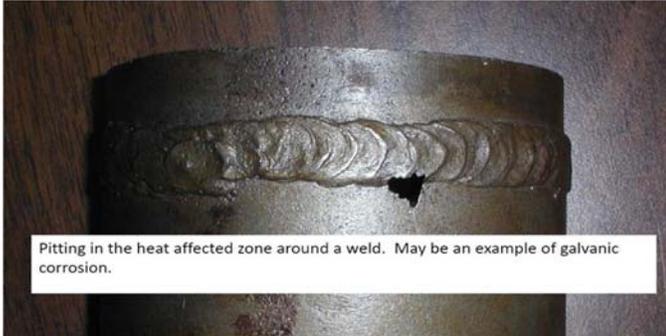
Galvanic Corrosion Cell between Weld Material and Pipe

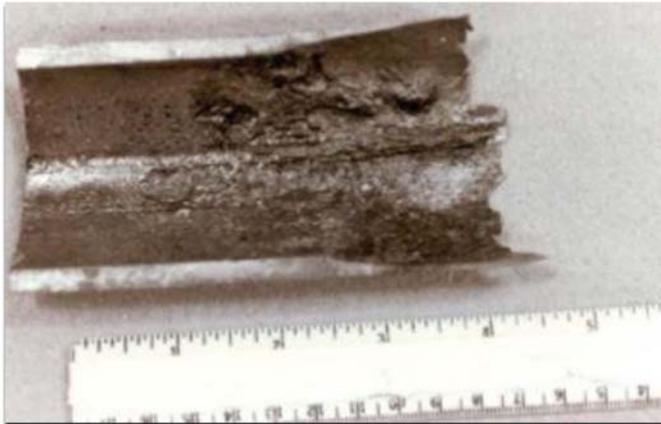
Ringworm Corrosion

Poorly Normalized Upset Tubing
